THE CALIFORNIA EARTHQUAKE OF APRIL 18, 1906

STATE EARTHQUAKE INVESTIGATION COMMISSION

VOLUME I, PART II

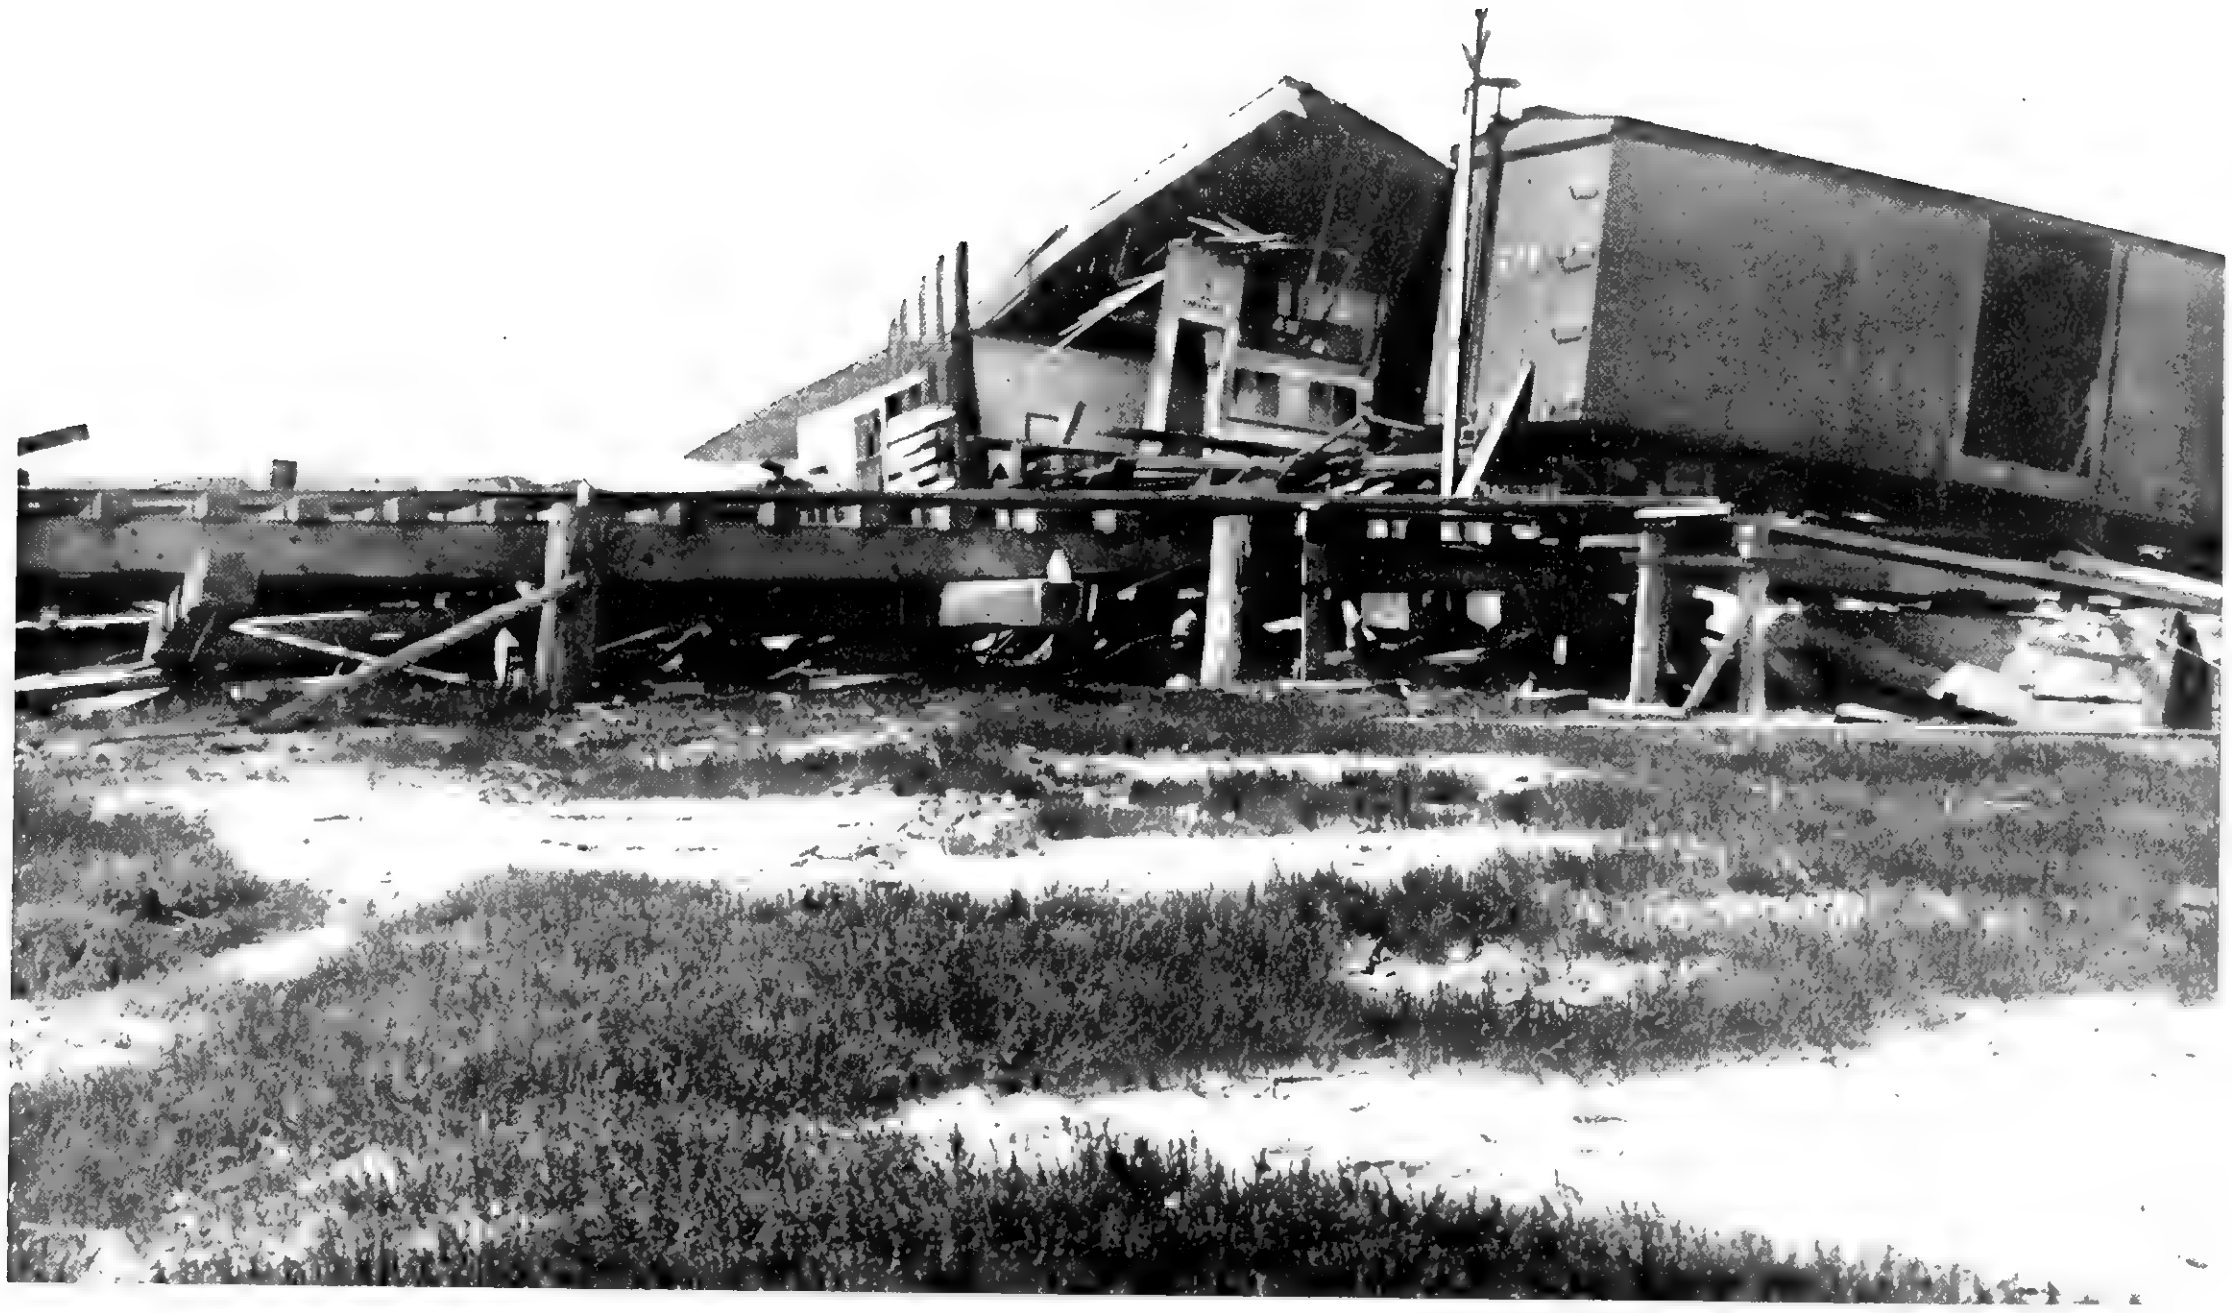
A. Moss Landing. Lurching of ground toward Salinas River, to left, carried piles from beneath bridge timbers and caused bridge to collapse. Displacement 9 feet. A. C. L.

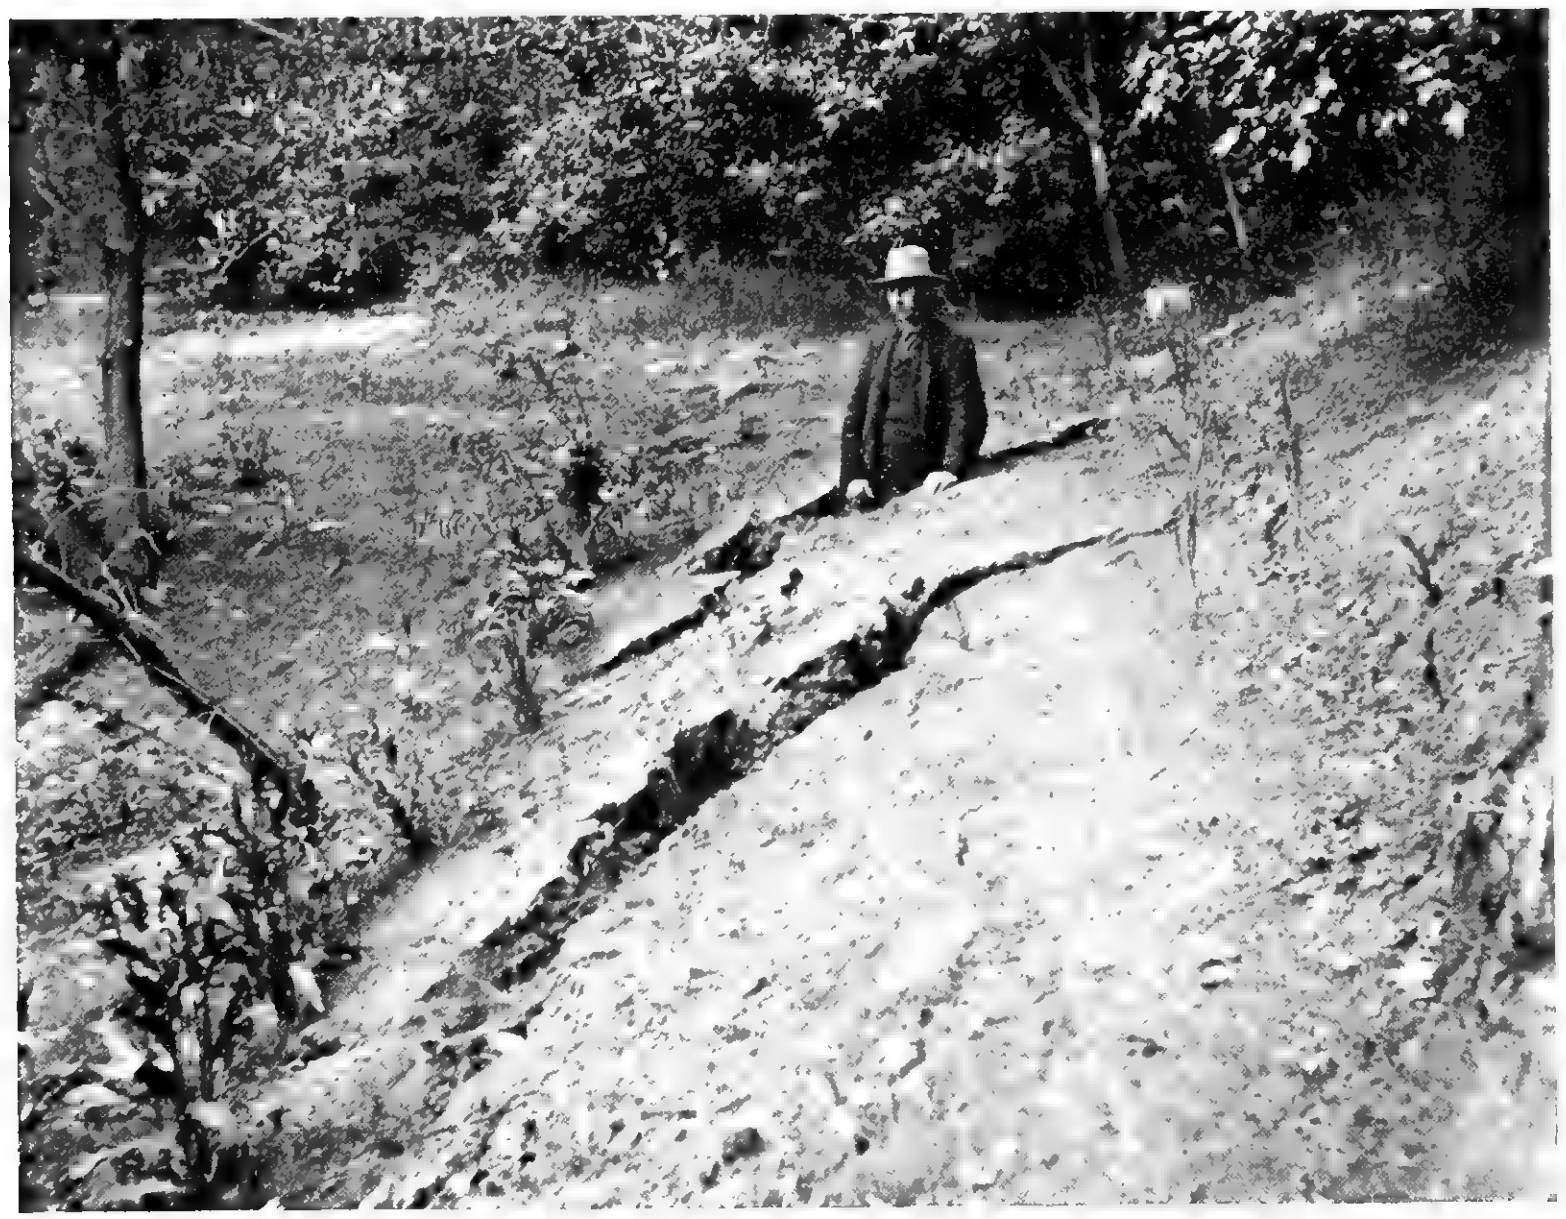
B. Russian River. Crack in flood-plain parallel to river. R. S. H.

C. Fissures in alluvium ; Tevis ranch, near Alma. I. H. S.

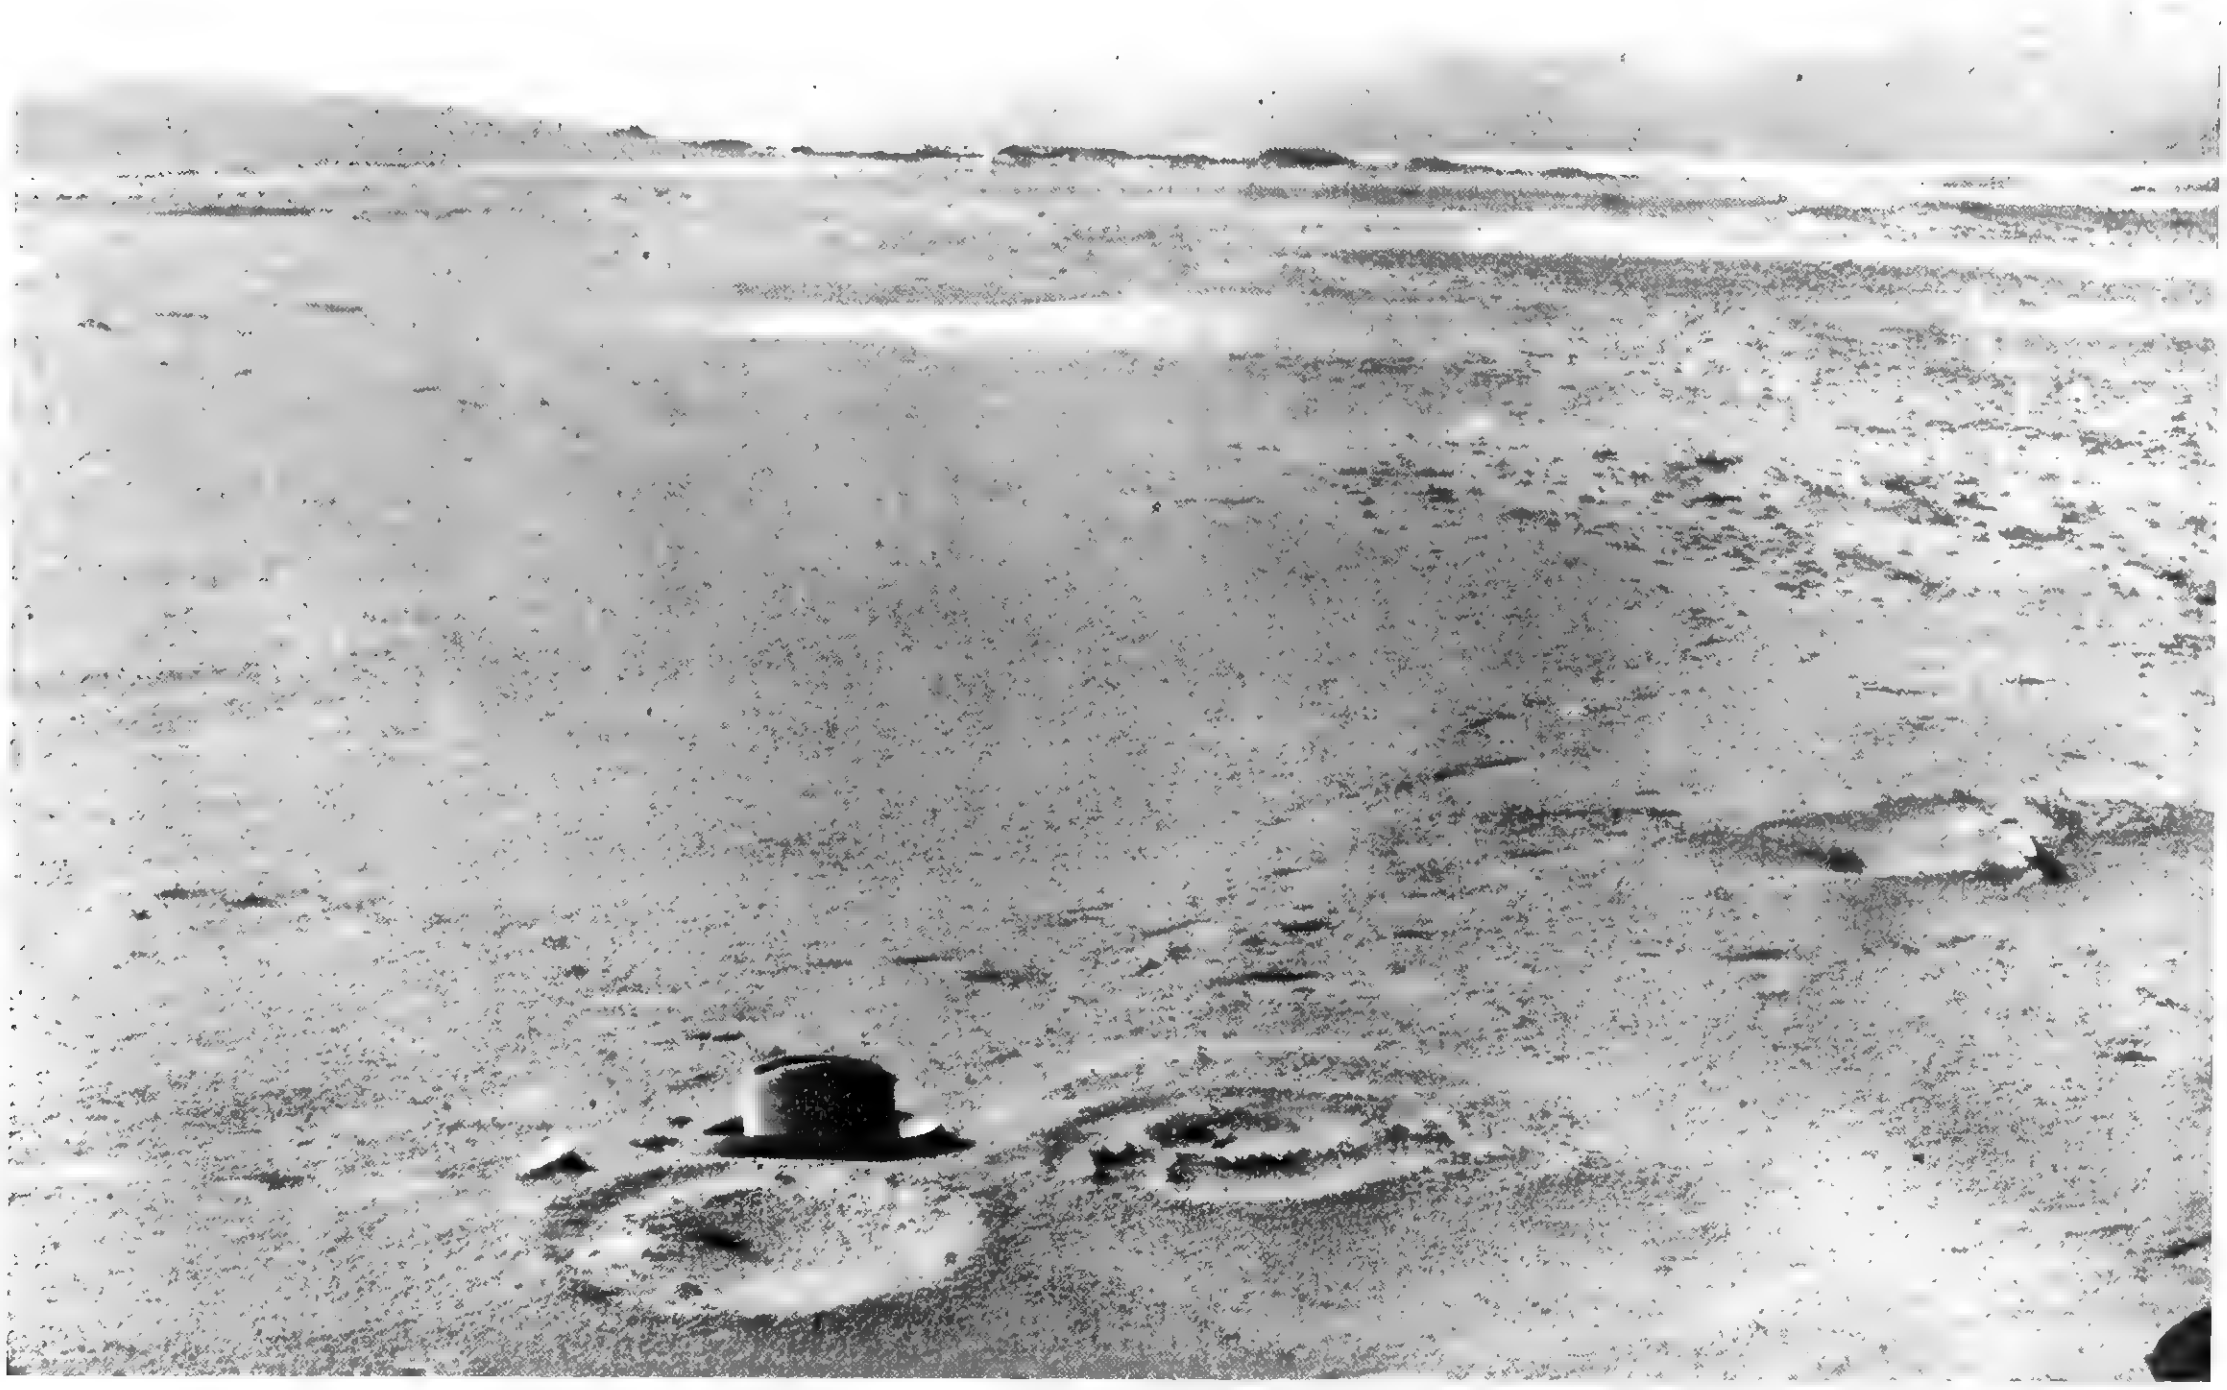
A. Craterlets in sand near marsh east of Bodega Bay. J. N. L.

B. Craterlets along fault-trace on sand spit at mouth of Tomales Bay. R. S. H.

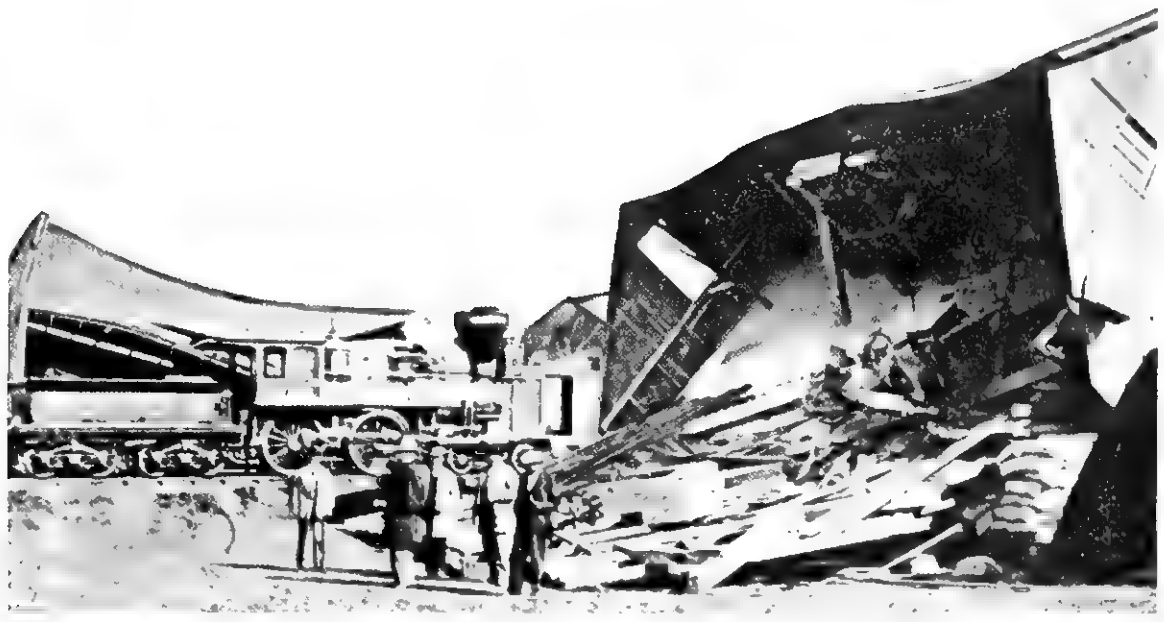
A. Flour mill, Haywards. Wrecked by earthquake of 1868.

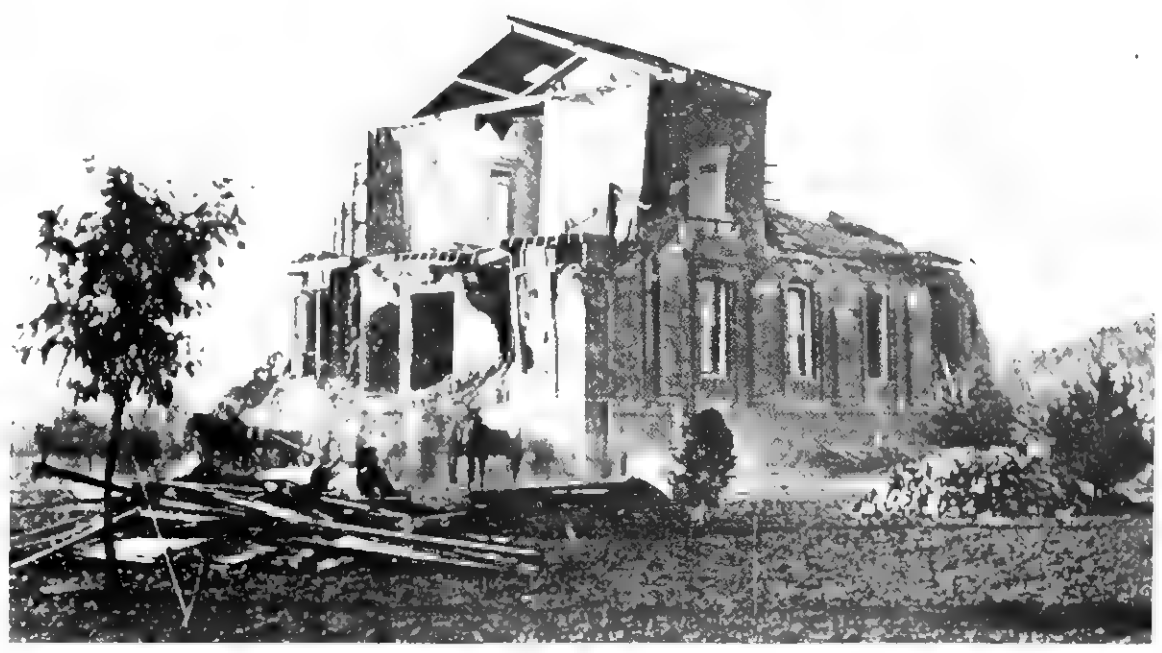
E. Haywards. Wreck of buildings by earthquake of 1868.

F. Court-house, San Leandro. Wrecked by earthquake of 1868.

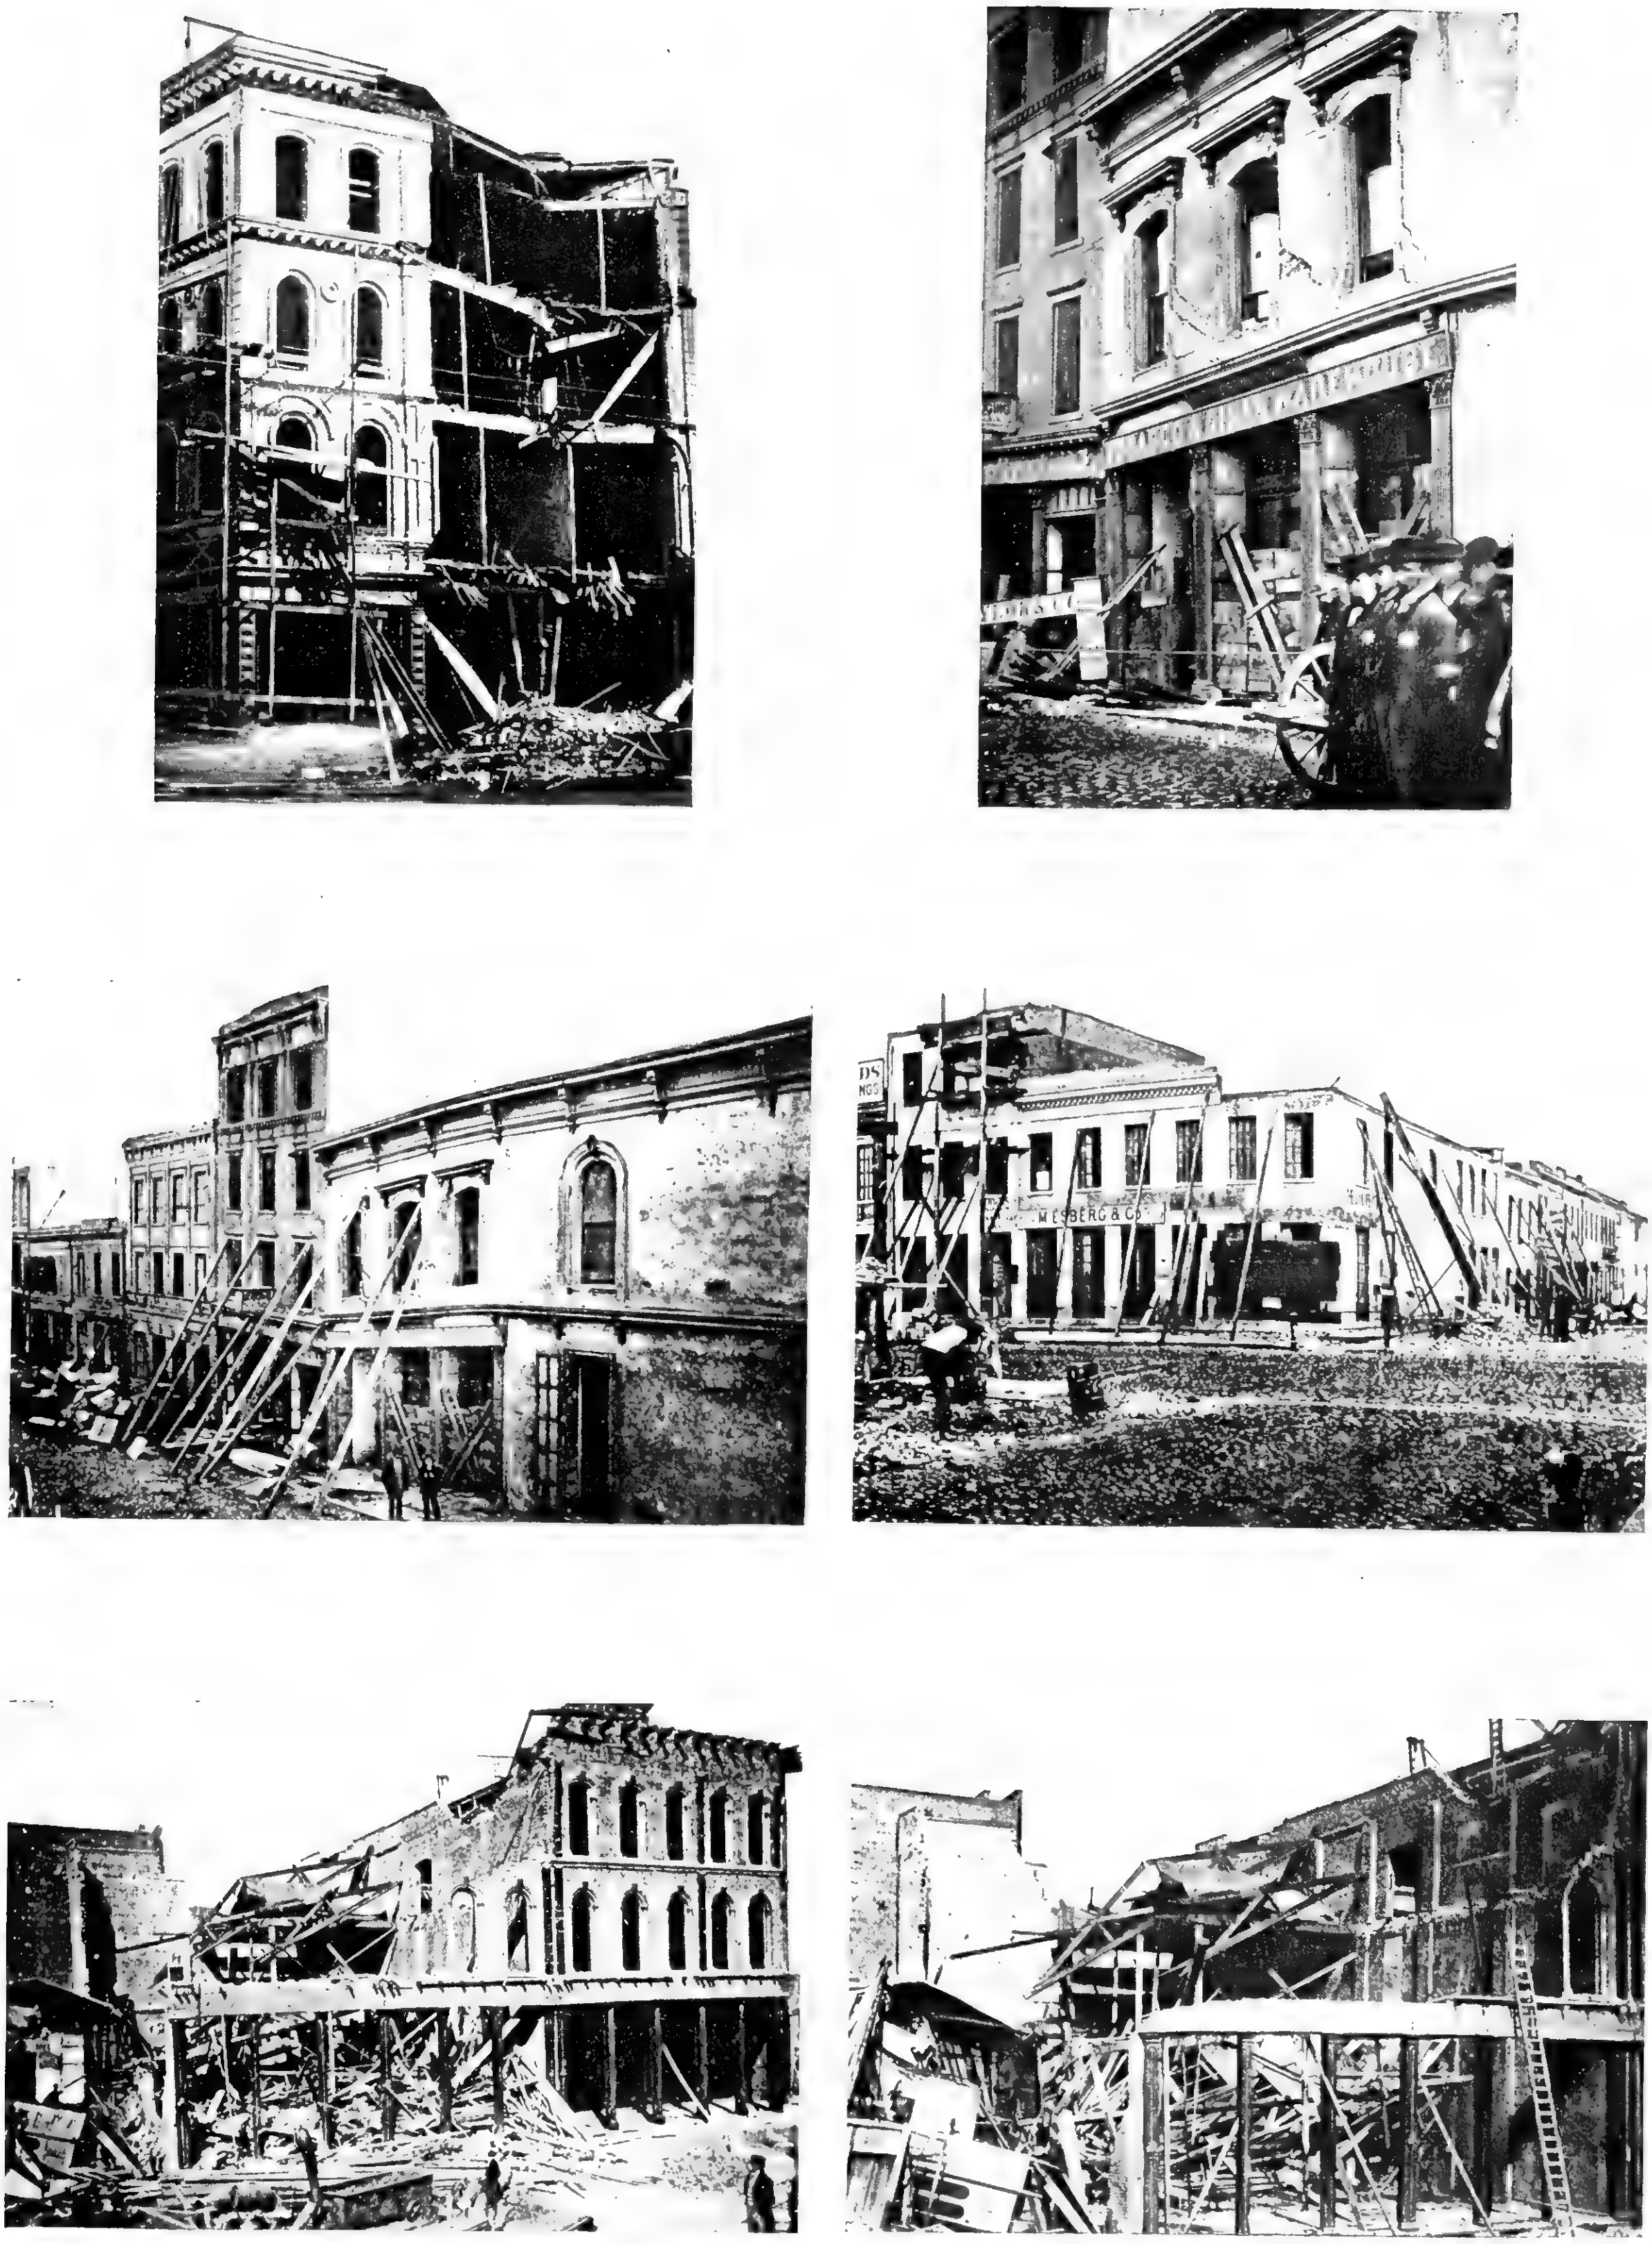
Effects of the earthquake of 1868 in San Francisco. From photographs preserved by Mr. H. Bendel.
